A Multi-Scale Approach to Assess and Restore Ecosystems in a Watershed Context

Ronald D. Smith and Charles V. Klimas

September 2013

Final report

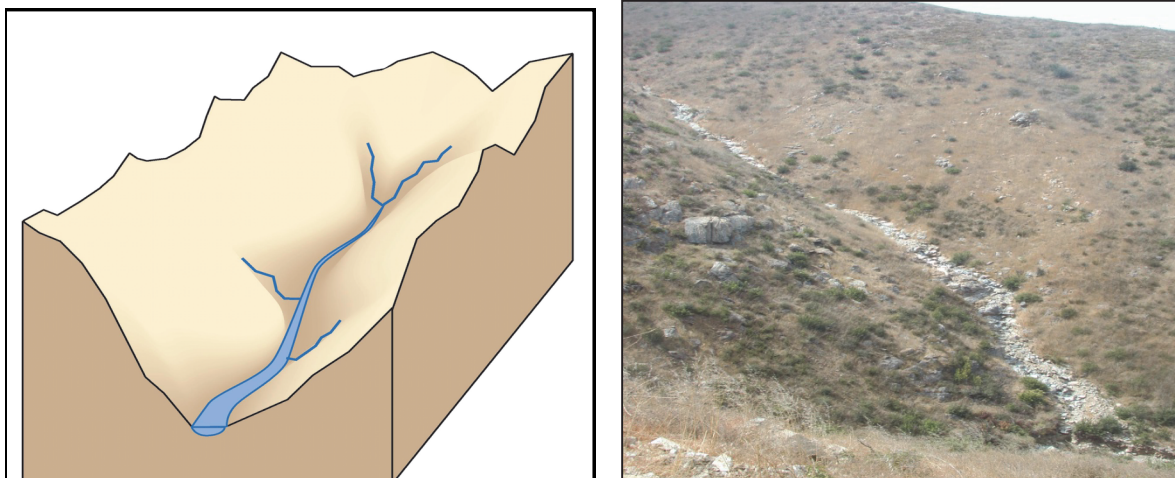
Figure C5. General form of Geomorphic Zone 1 and view of typical reach.

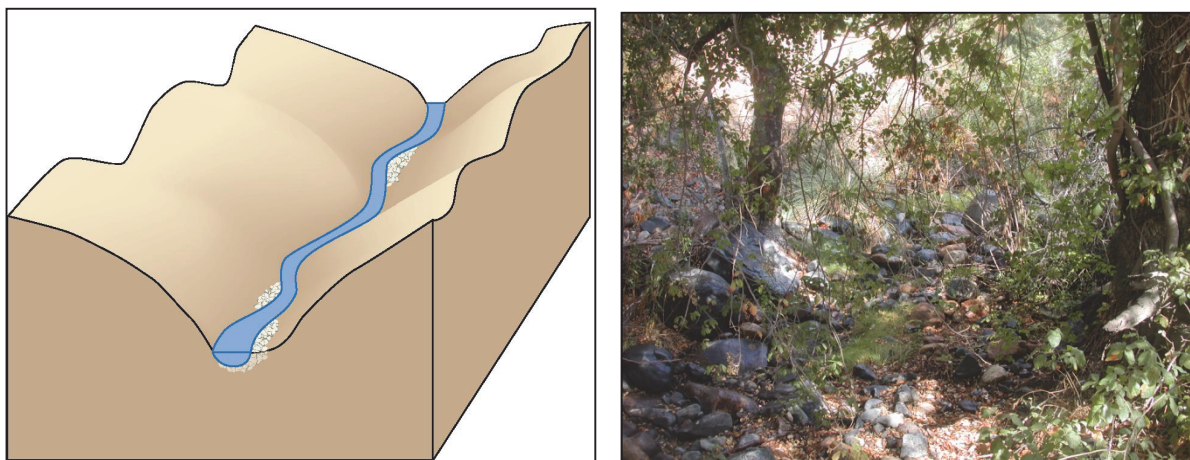
Figure C6. General form of Geomorphic Zone 2 and view of typical reach.

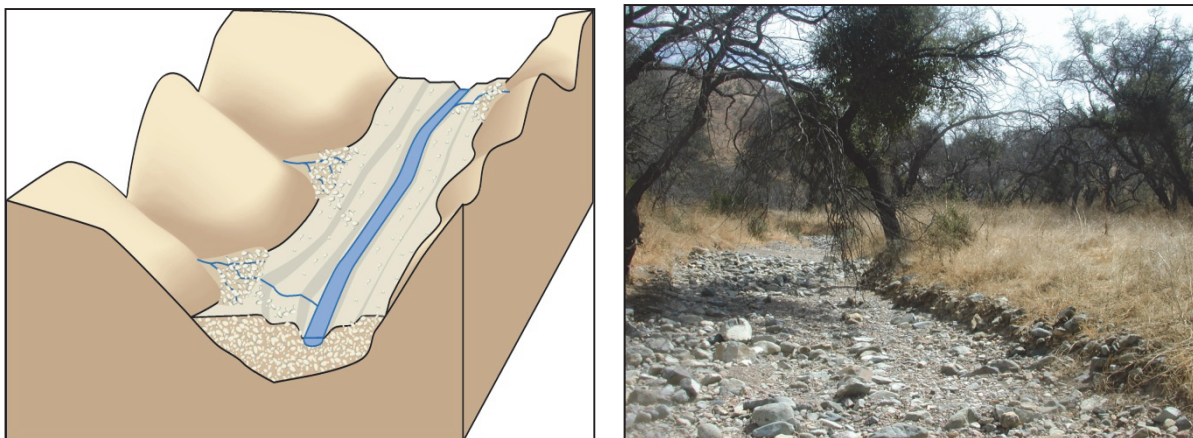
Figure C7. General form of Geomorphic Zone 3 and view of typical reach.

Zone 3 reaches occur at and below the confluence of high-gradient tributary streams with larger channels. The steep tributaries deliver coarse, unsorted materials, which are distributed downstream. Usually, the main channel runs across bare cobbles and boulders, while the slightly higher adjacent terraces will have a shallow soil that fills between the rocks and forms a rough, but fairly level surface. Because the terraces consist of very coarse material, they typically support upland shrubs. Oaks and sycamores are often present but usually as scattered individuals. Overall, however, continuous riparian communities are restricted to the immediate vicinity of the stream channels. Very few reaches were designated as Geomorphic Zone 3, but where it occurs, it is distinctive.

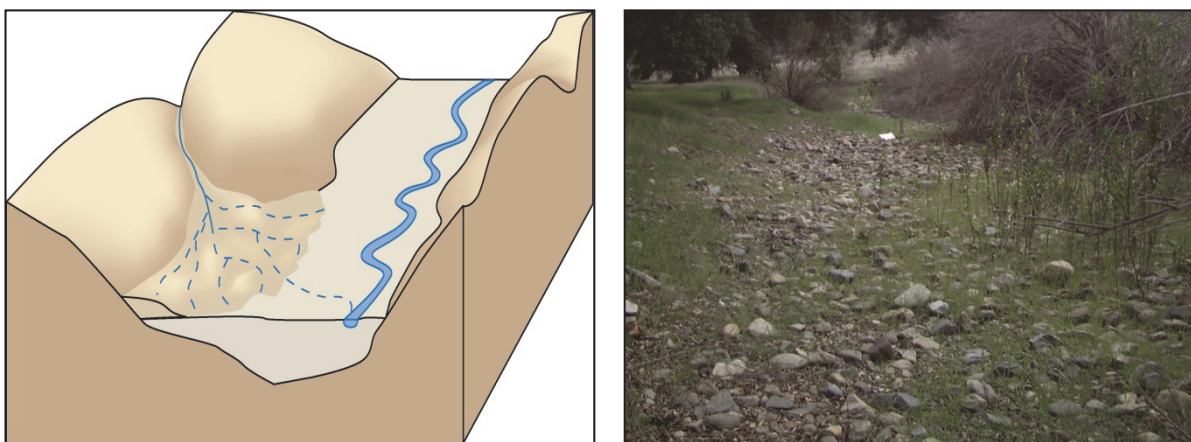
Figure C8. General form of Geomorphic Zone 4 and view of typical reach.

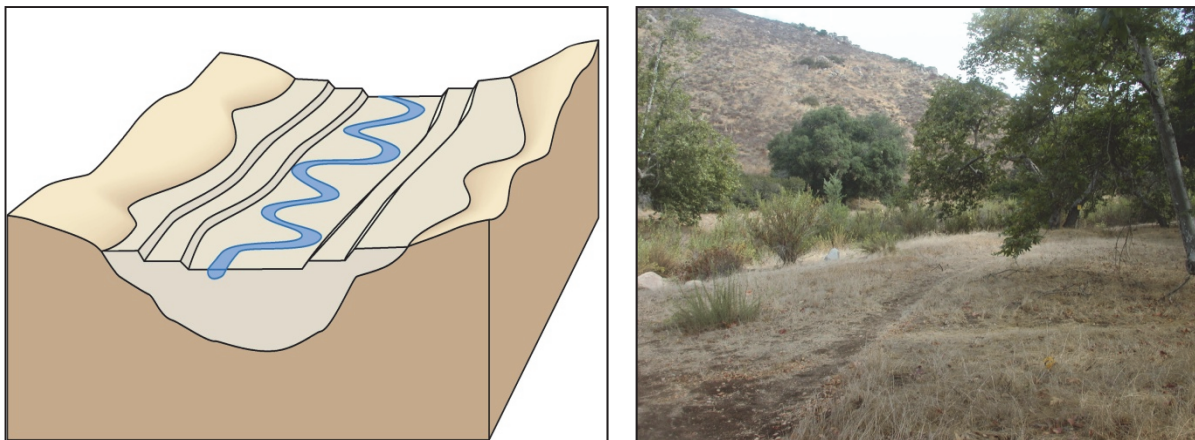
Figure C9. General form of Geomorphic Zone 5 and view of typical reach.

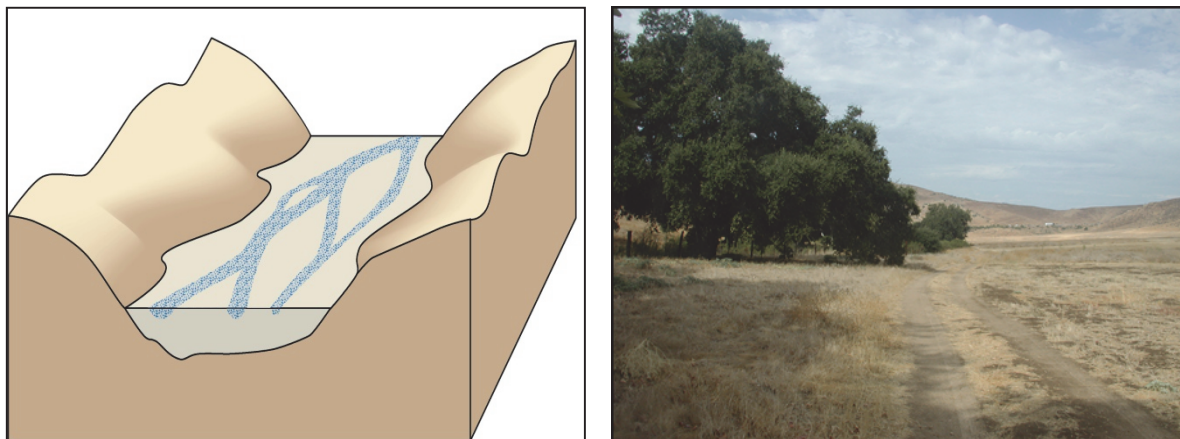
Figure 10. General form of Geomorphic Zone 6 and view of typical reach.

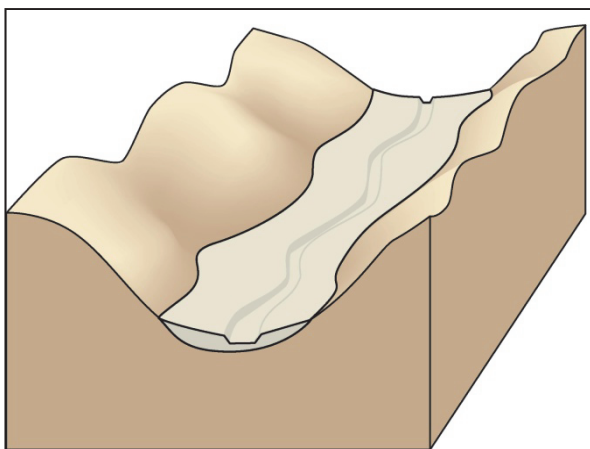
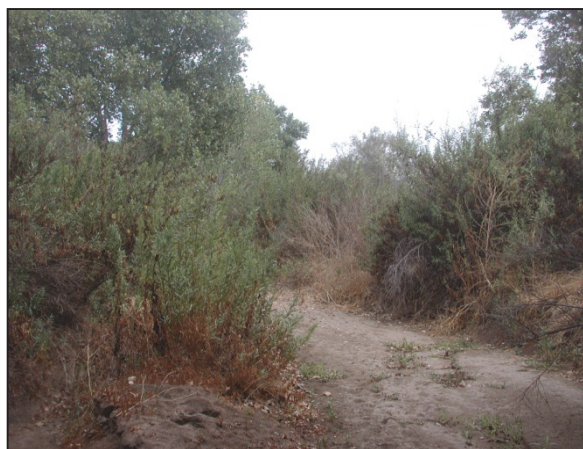
Figure C11. General form of Geomorphic Zone 7 and view of typical reach.

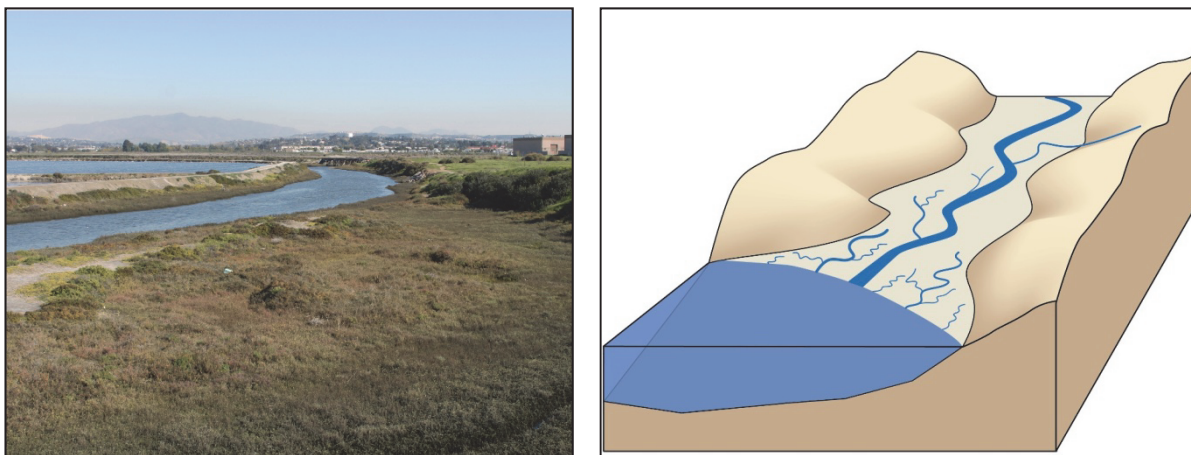
Figure C12. General form of Geomorphic Zone 8 and view of typical reach.

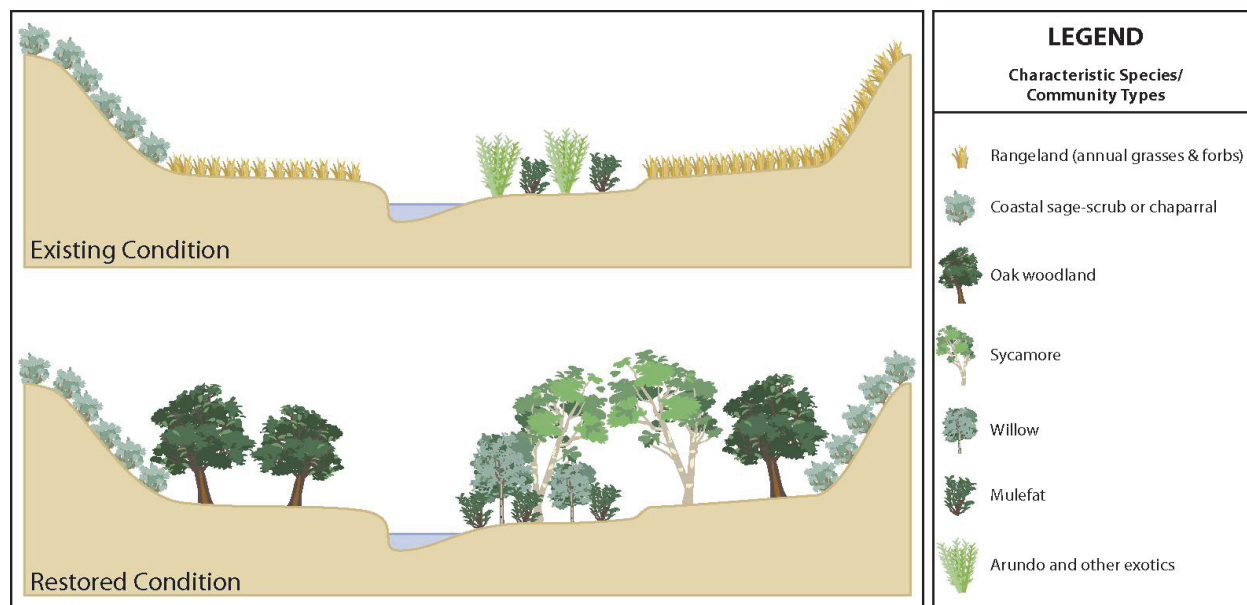
Figure C13. Typical pre- and post-restoration conditions of the Natural Template.

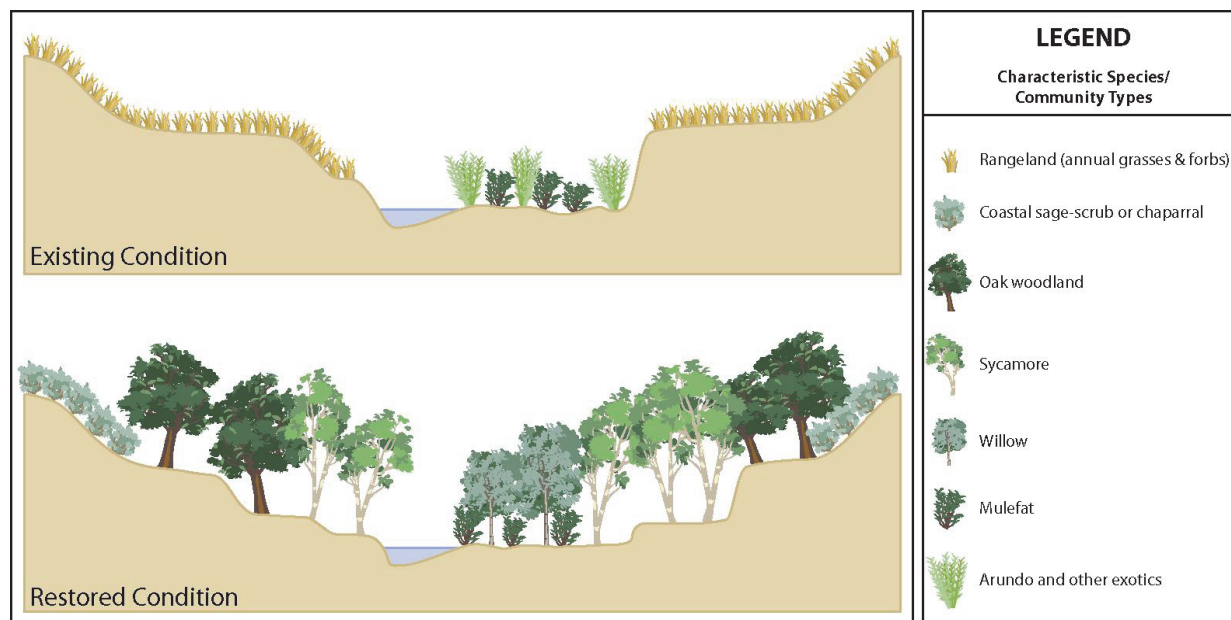
Figure C14. Typical pre- and post-restoration conditions of the Incised Template.

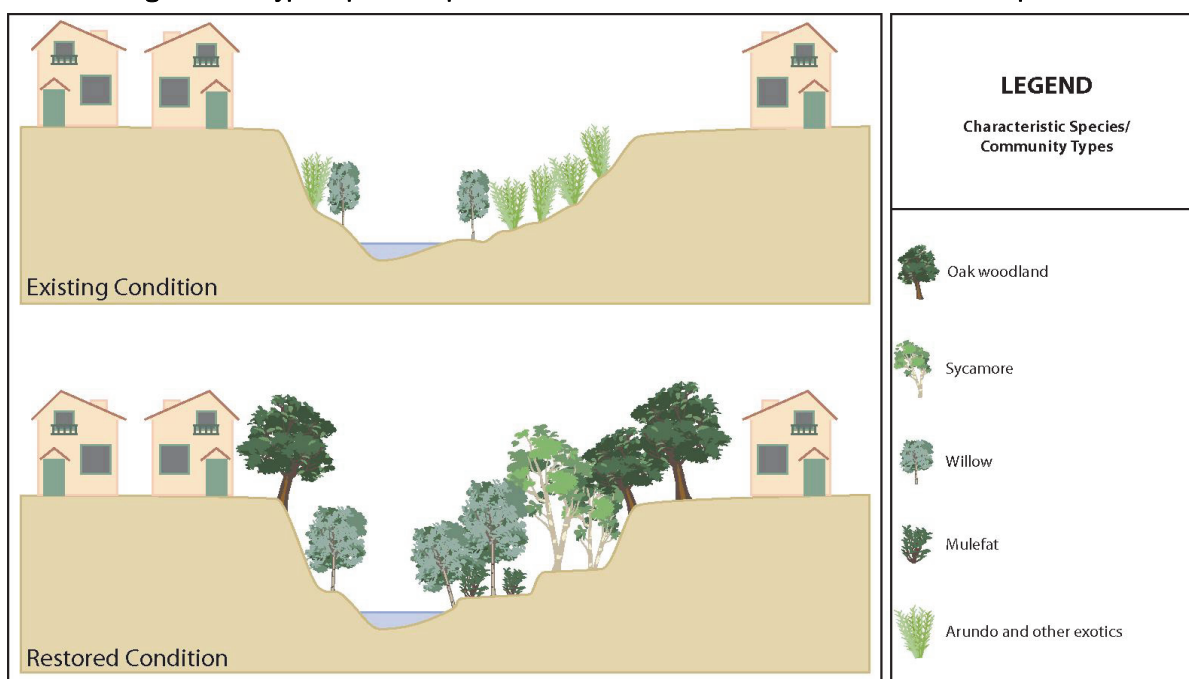
Figure C15. Typical pre- and post-restoration conditions of the Constrained Template.
